## Elevation is Cause for Elation When Damage is Avoided

### Full Mitigation Best Practice Story

#### *Owen County, Indiana*

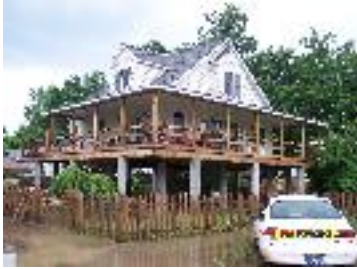
House elevated on 8-ft. "rebar" pillars

She found plans for a coastal-style house, hired an architect to draft the plans, and an engineer to design the reinforced-cement pillars that would hold the 2,000-square-foot house a total of eight feet above the ground. This would not only keep her safe from flooding but also allow her to plant some trees, a garden, and set aside an area with lawn furniture, which could be quickly moved upstairs. According to ICC regulations, the open area underneath the house has to remain unencumbered to allow floodwater to pass safely through.
